**NCHRP REPORT 350 TESTING OF  
MONTANA PORTABLE CONCRETE  
SAFETY SHAPE BARRIERS**

**TEXAS TRANSPORTATION INSTITUTE  
THE TEXAS A&M UNIVERSITY SYSTEM  
COLLEGE STATION, TEXAS 77843**

1. Report No. <b>FHWA/MT-03-002/8162</b>		2. Government Accession No.	3. Recipient's Catalog No.
4. Title and Subtitle <b>NCHRP Report 350 Testing of the Montana Portable Concrete Safety Shaped Barriers</b>		5. Report Date <b>April 2003</b>

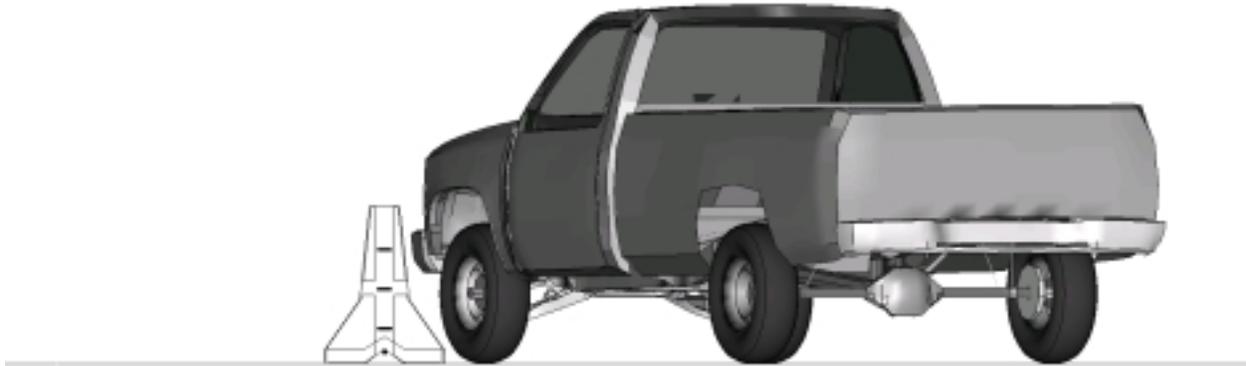
Figure 2.2.6 shows the overhead view of the full-scale simulation of the modified pin-and-loop barrier before and after impact. Figure 2.2.7 shows a rear view of the simulation. Figure 2.2.8 shows the field side of the barrier joint at which maximum deflection occurred at time of contact and as the vehicle is exiting the barrier system.

**Figure 2.2.7.** Rear view of simulation of modified pin-and-loop barrier connection.

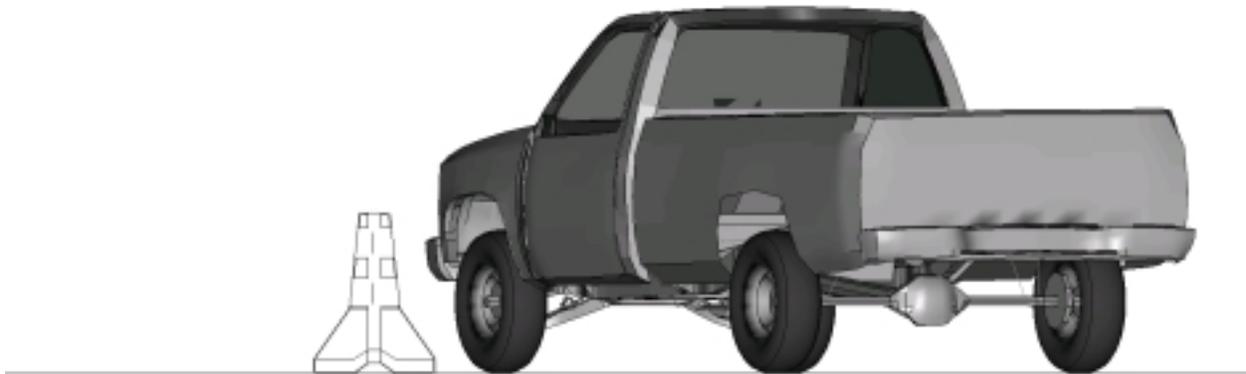
**Figure 2.2.11.** Rear view of simulation of lapped plate barrier connection.

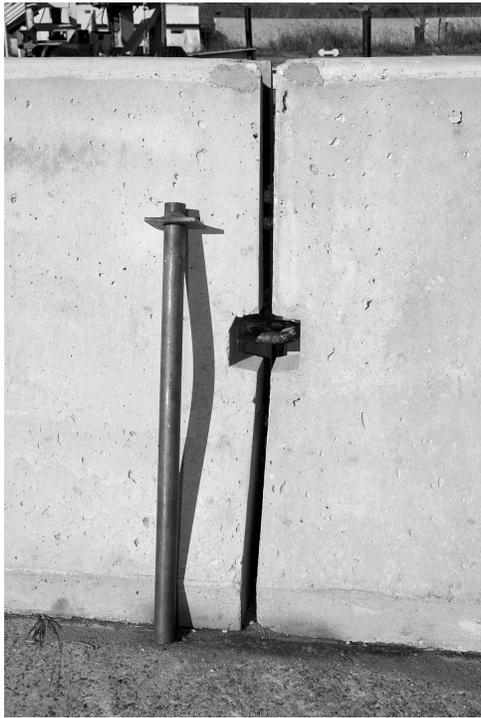
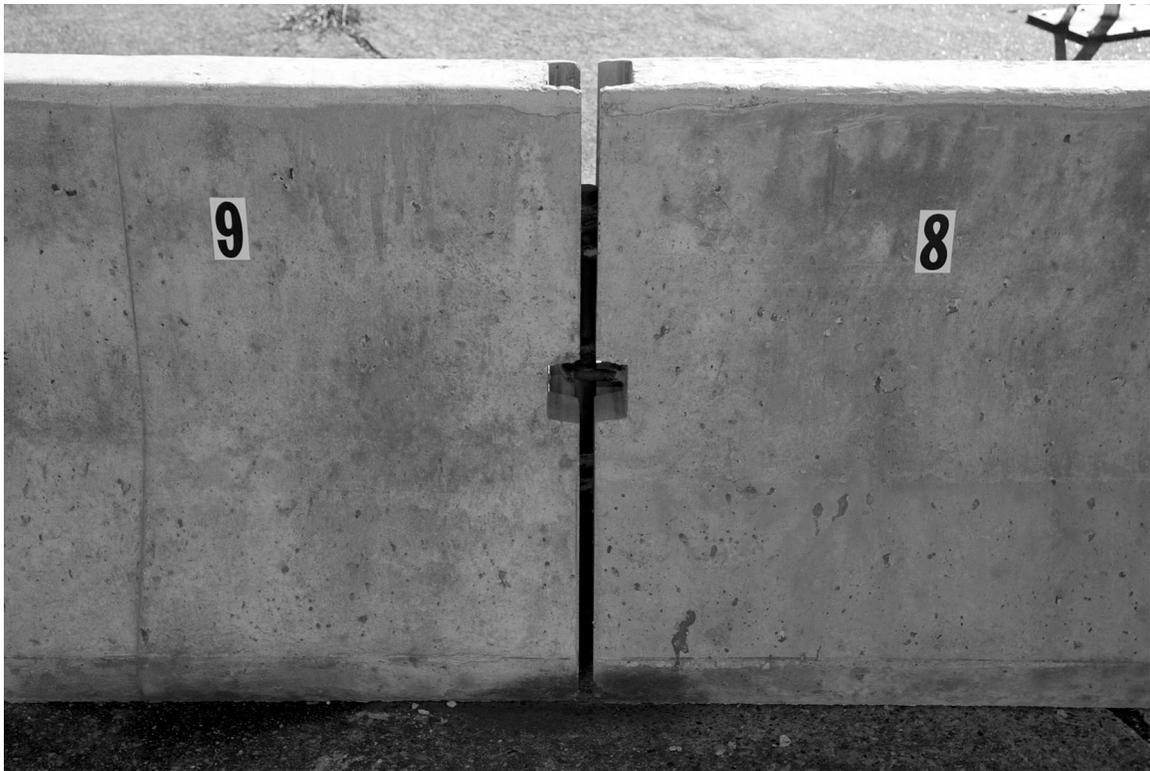
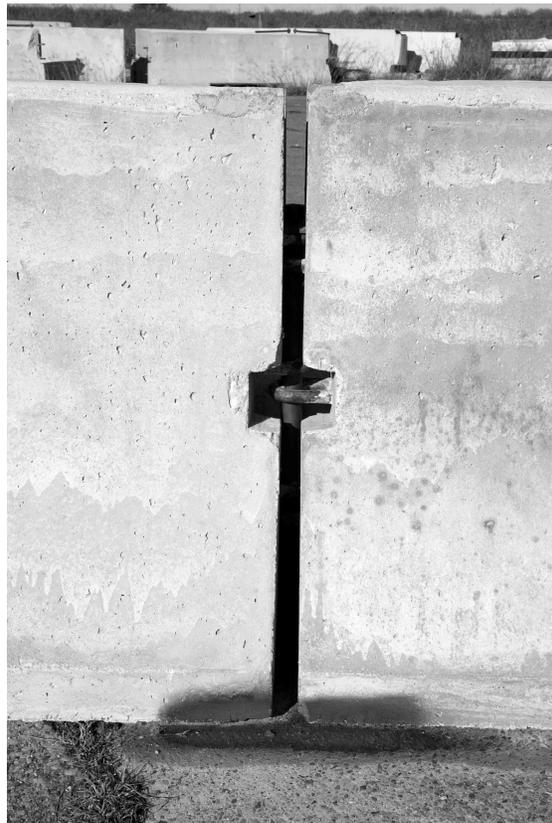
**Figure 3.2.2.** Modified pin-and-loop barriers prior to test 474550-1.

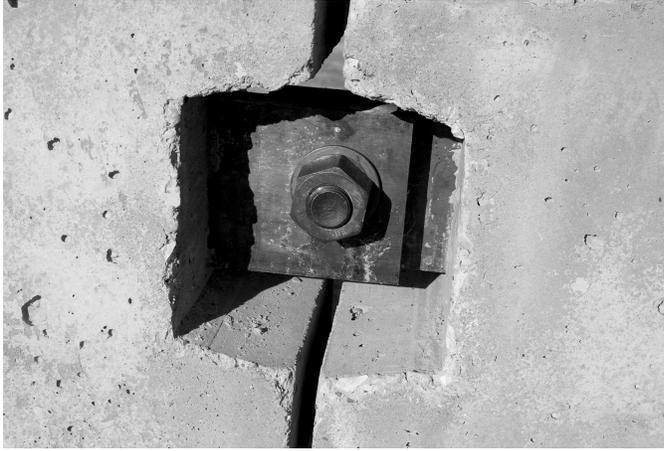
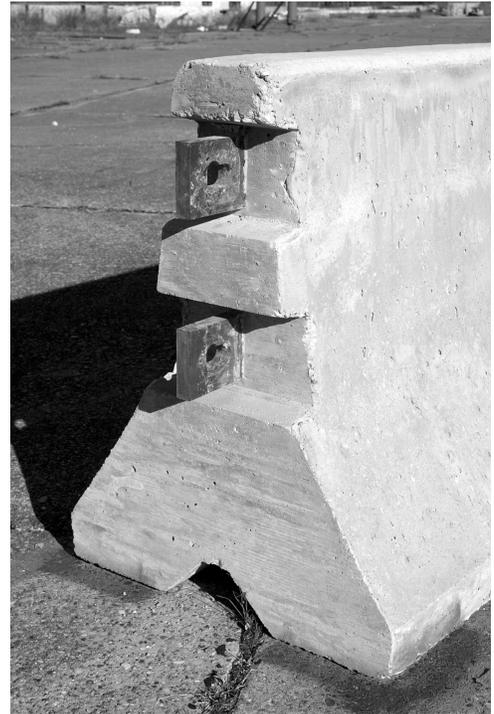
**Figure 3.2.4.** Lapped splice connection barriers prior to test 474550-2.

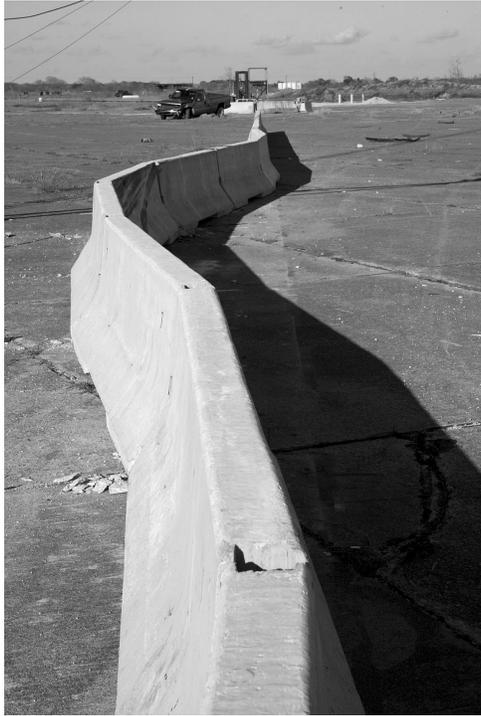
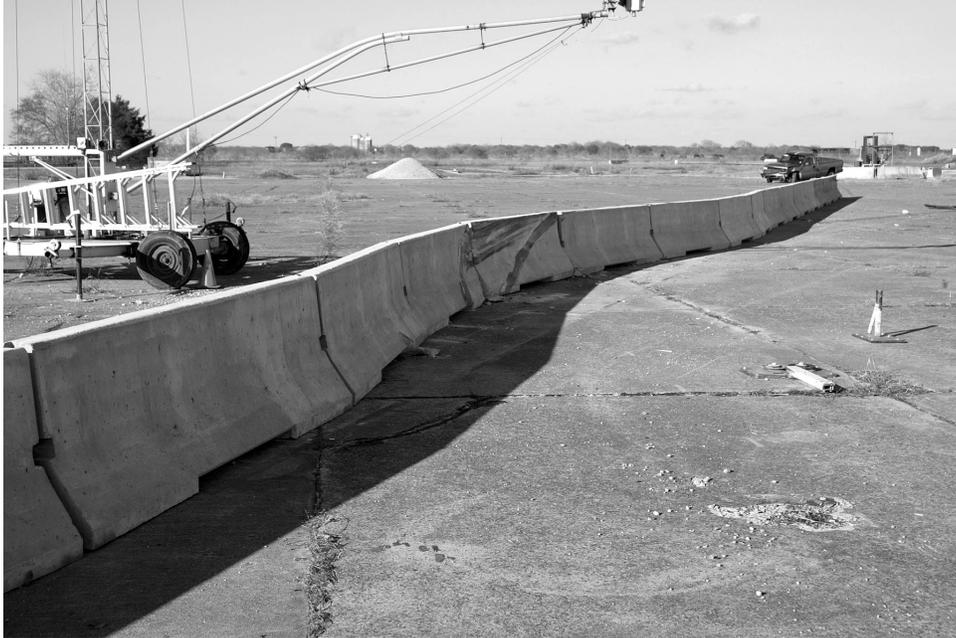
Brakes on the vehicle were applied at 2.2 s after impact. The vehicle subsequently came to rest 61.8 m (202.8 ft) downstream of impact and 3.8 m (12.5 ft) behind the traffic face of the barriers. Sequential photographs of the test period are shown in Appendix C, Figures C.1.1 and C.1.2.

**Figure 4.4.1.** Vehicle trajectory after test 474550-1.

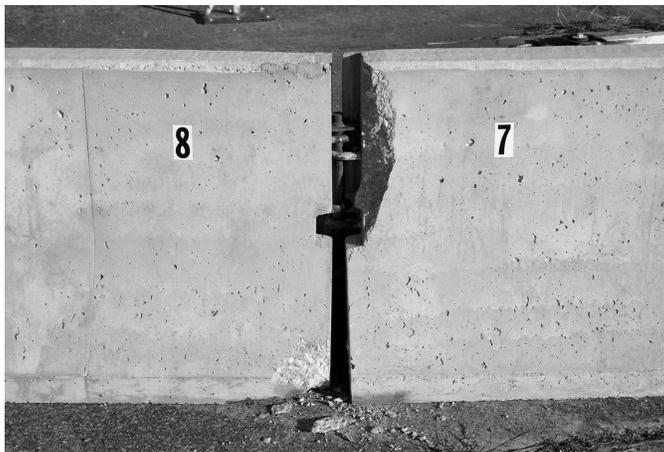
Damage to the barriers is shown in Figures 4.4.1 and 4.4.2. The connection pins were deformed between segments 8 and 9, and 9 and 10; and slightly bent between segments 7 and 8, 10 and 11, and 11 and 12. The upstream end of the installation was pulled longitudinally 135 mm (5.3 inches) and the downstream end 5 mm (0.2 inch). The vehicle was in contact with the installation from 1.22 m (4.0 ft) upstream of joint 8-9, and various places along the top of the barrier before it came off the barrier 0.23 m (0.75 ft) from the end of the last barrier (segment 20). Maximum dynamic movement of the barriers toward the field side was 1.27 m (4.2 ft), at which the barriers remained for a permanent deformation of 1.27 m (4.2 ft).

**Figure 4.4.2.** Modified pin-and-loop barrier installation after test 474550-1.

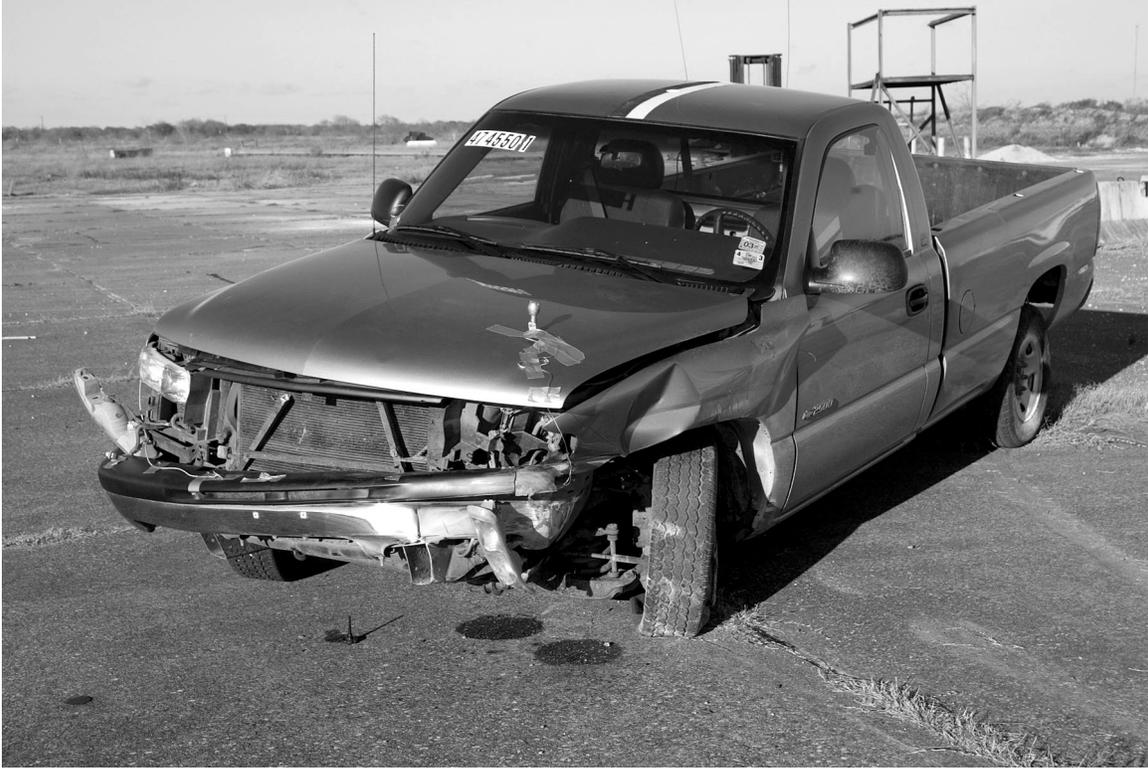
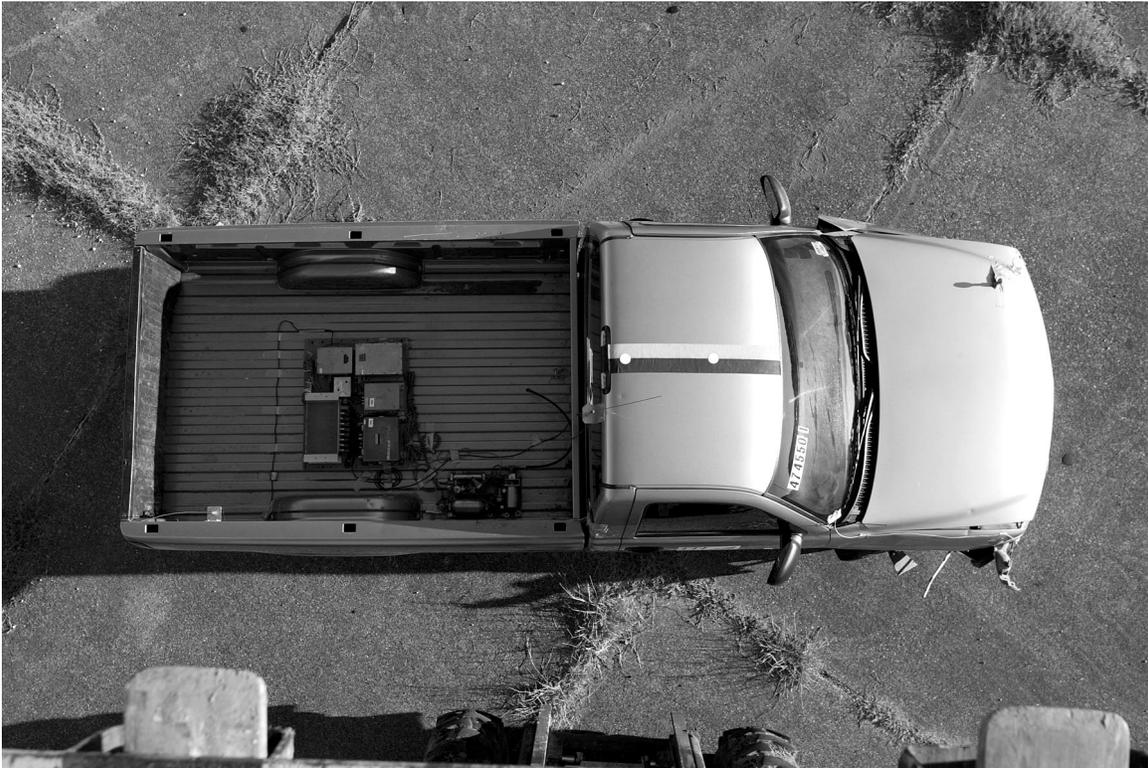
Most of the damage to the vehicle was to the left front quarter, as shown in Figure 4.5.1. Structural damage was imparted to the front left of the frame rail and left side firewall and floor pan area. Also damaged were the front bumper, hood, grill, radiator, fan, left front quarter panel, and left front tire and wheel rim. The left rear wheel rim was also deformed but the tire had no loss of air. Maximum exterior crush of the vehicle was 420 mm (16.5 inches) in the side plane at the left front corner near bumper height. Maximum occupant compartment deformation was 20 mm (0.8 inch) in the left floor pan area near the toe pan, and there was very slight separation of the seam between the floor pan and firewall. Photographs of the interior of the vehicle are shown in Figure 4.5.2. Exterior vehicle crush and occupant compartment measurements are shown in Appendix B, Tables B.1.1 and B.1.2.

Figure 4.5.1. Vehicle after test 474550-1.

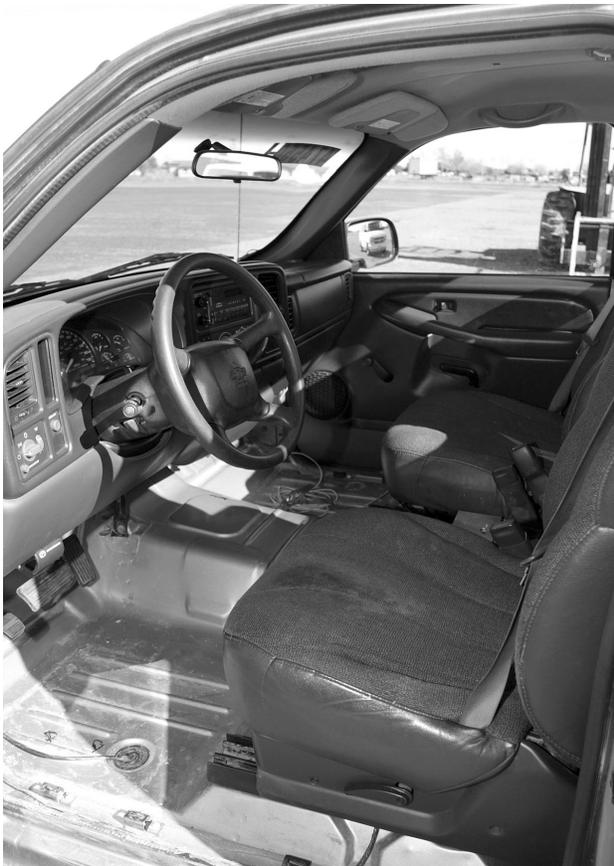
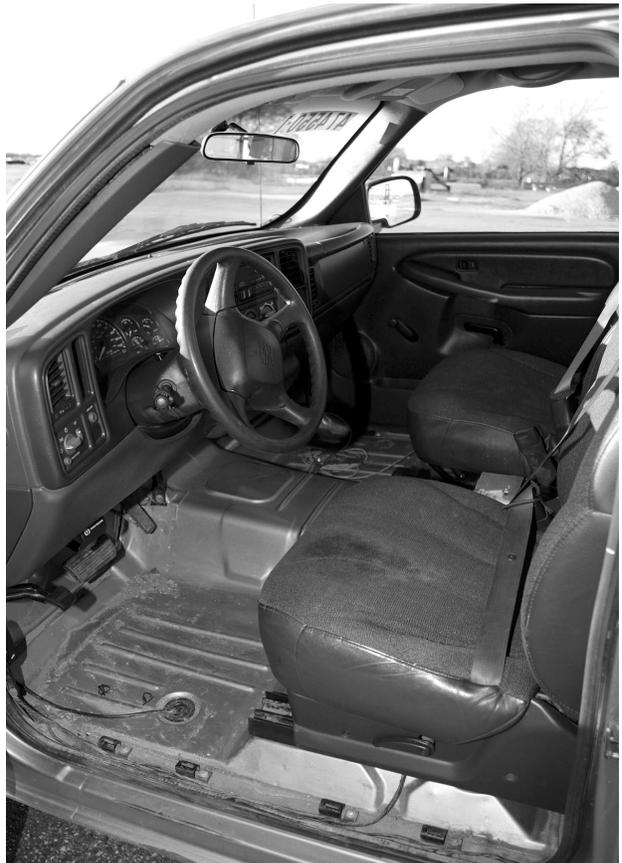
**Figure 4.5.2.** Interior of vehicle for test 474550-1.

Result: No detached elements, fragments, or other debris was present to penetrate or to show potential for penetrating the occupant compartment, or to present undue hazard to others in the area. Maximum occupant compartment deformation was 20 mm (0.8 inch) in the left side floor pan near the toe pan.

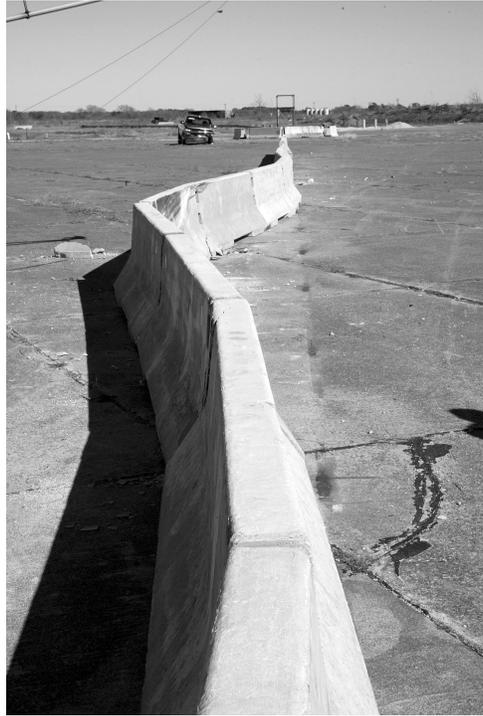
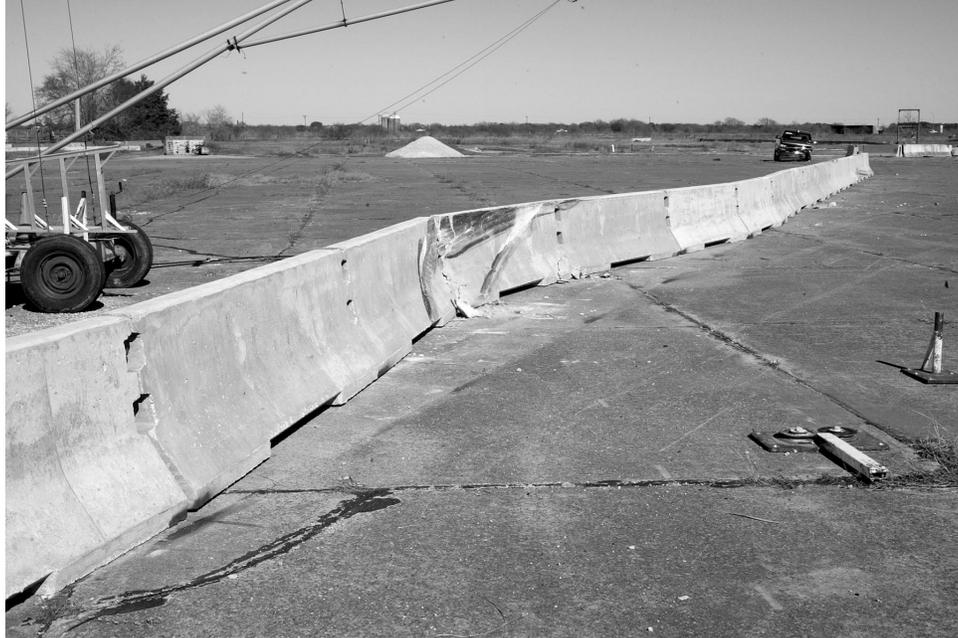
Brakes on the vehicle were applied at 2.5 s after impact. The vehicle subsequently came to rest 25.9 m (85.0 ft) downstream of the end of the barrier and 2.3 m (7.5 ft) toward the field side of the traffic face of the barrier. Sequential photographs of the test period are shown in Appendix C, Figures C.2.1 and C.2.2.

**Figure 5.4.1.** Vehicle trajectory after test 474550-2.

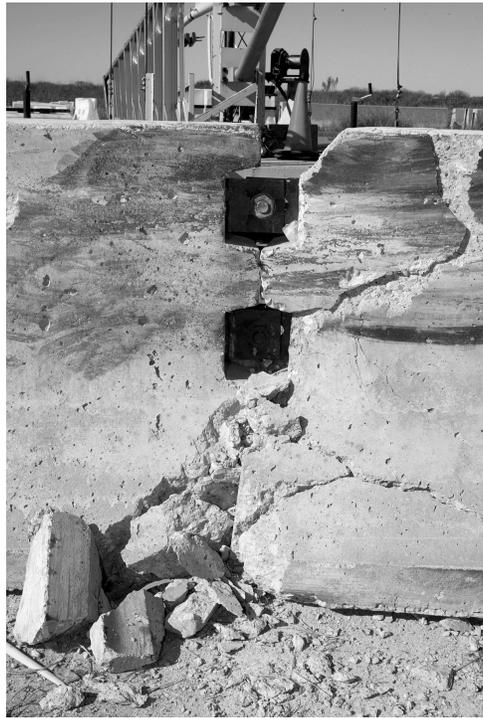
Damage to the barriers is shown in Figures 5.4.1 and 5.4.2. The upstream end of the installation was pulled longitudinally 128 mm (5.0 inches) and the downstream end 5 mm (0.2 inch). The vehicle was in contact with the installation from 1.36 m (4.4 ft) upstream of joint 8-9, all along segment 9, and 1.87 m (6.1 ft) along segment 10. The vehicle then contacted the traffic face of the installation at various locations. Maximum dynamic movement of the barriers toward the field side was 1.10 m (3.6 ft), at which the barriers remained for a permanent deformation of 1.10 m (3.6 ft).

**Figure 5.4.2.** Lapped splice barrier installation after test 474550-2.

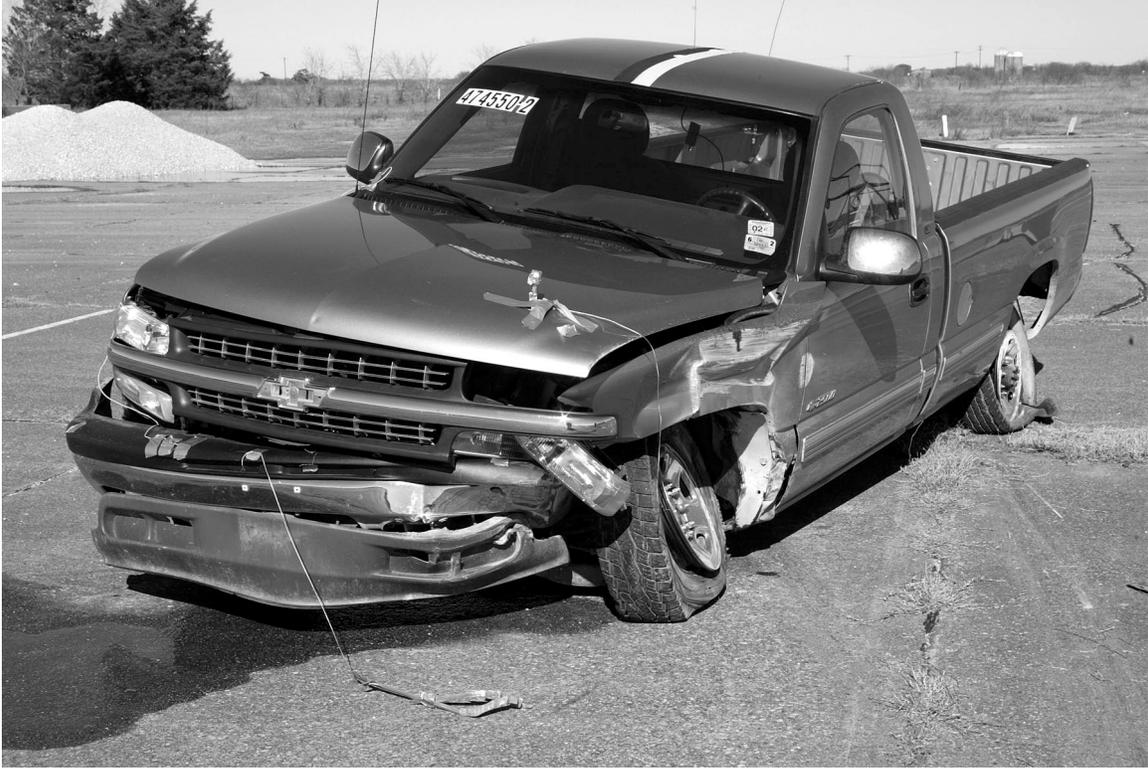
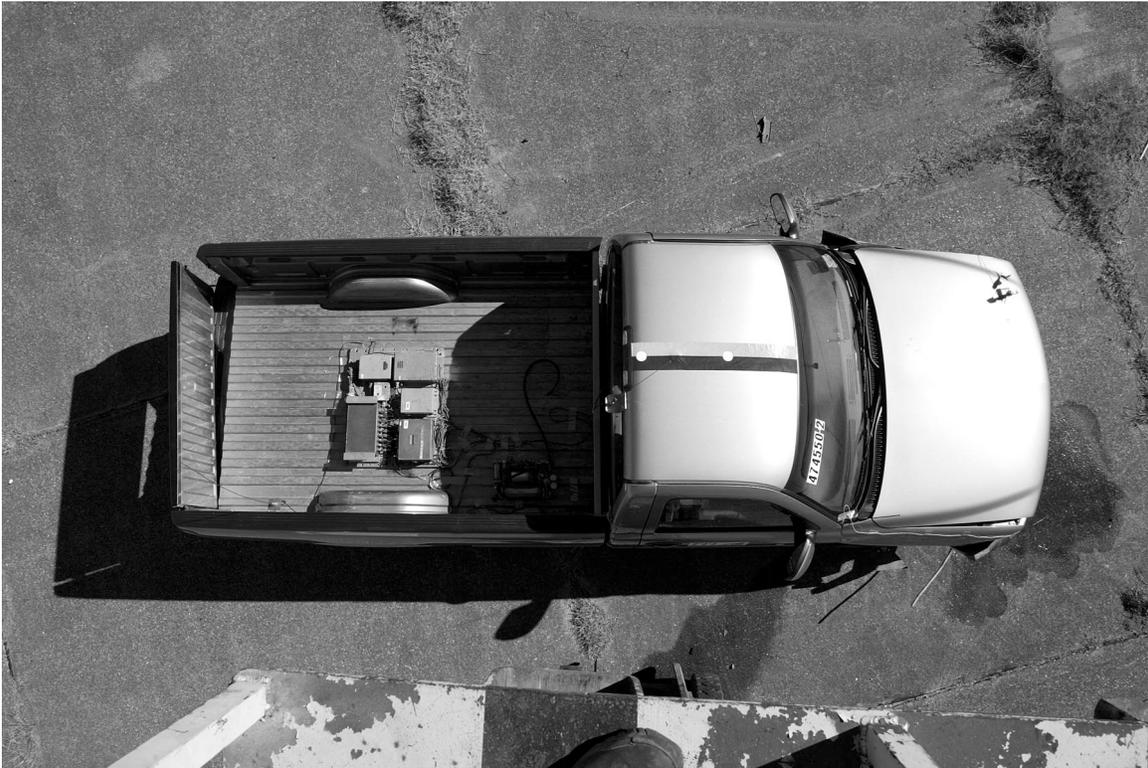
Most of the damage to the vehicle was to the left front quarter, as shown in Figure 5.5.1. Structural damage was imparted to the left lower A-arm and left side firewall and floor pan area. Also damaged were the front bumper, hood, grill, radiator, fan, left and right front quarter panels, left door, and left front and rear tire and wheel rim. Maximum exterior crush of the vehicle was 400 mm (15.7 inches) in both the side plane and front plane at the left front corner near bumper height. Maximum occupant compartment deformation was 21 mm (0.8 inches) in the left floor pan area near the toe pan, and there was very slight separation of the seam between the floor pan and firewall. Photographs of the interior of the vehicle are shown in Figure 5.5.2. Exterior vehicle crush and occupant compartment measurements are shown in Appendix B, Tables B.2.1 and B.2.2.

Figure 5.5.1. Vehicle after test 474550-2.

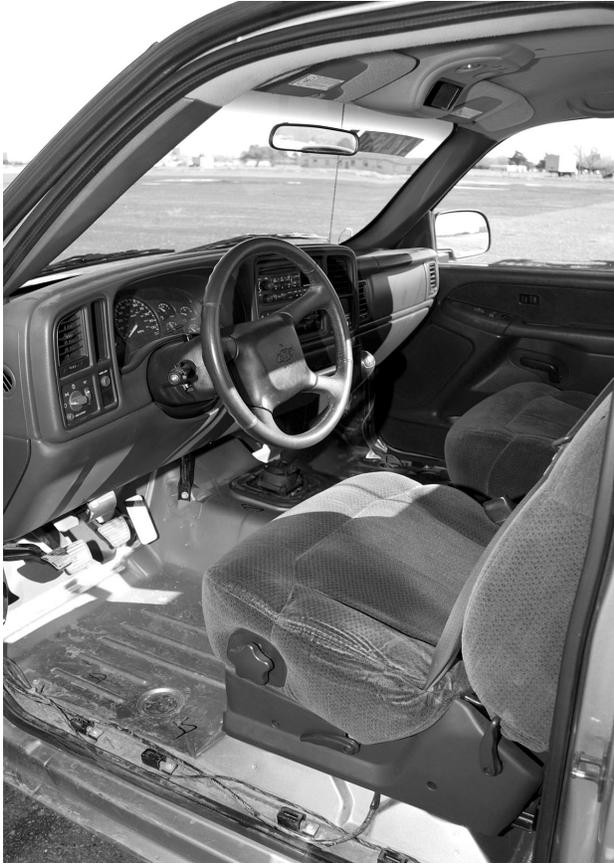
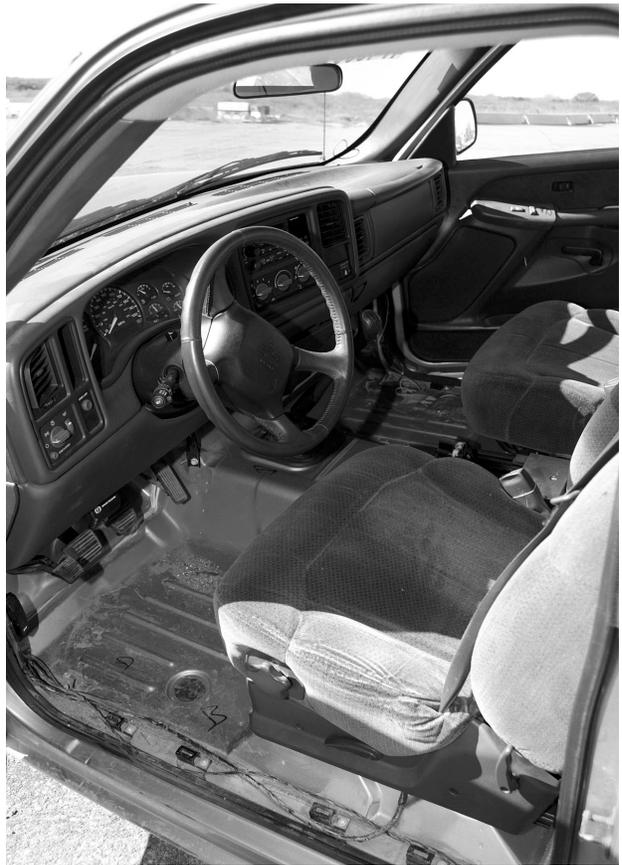
**Figure 5.5.2.** Interior of vehicle for test 474550-2.

Result: No detached elements, fragments, or other debris was present to penetrate or to show potential for penetrating the occupant compartment or to present undue hazard to others in the area. Maximum occupant compartment deformation was 21 mm (0.8 inch) in the driver's side floor pan near the toe pan.
